Address: 236 North Main Street

Historic Building Name: A. Rating House

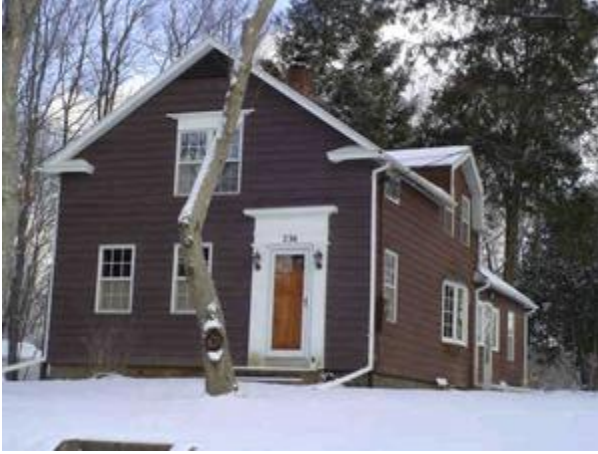
Description: The front elevation of the house is the three-bay gable end, with door to the south. The doorway consists of flanking pilasters supporting an architrave, wide frieze, and flat cornice. The two windows to the north are 6-over-6. In the second floor, above, there is a pair of 6-over-6 windows. On the south side elevation, first floor, window sequence is one 6-over-6 sash followed by a tall eight-pane window, then the added one-story ell. At the second floor there is a rectangular window under the eaves toward the front, while an added gambrel-roofed dormer is just before the ell.

Significance: The front doorway of pilasters and entablature as part of the three-bay first-floor fenestration articulate the Greek Revival style, as does the eaves window on the south. However, the paired second-floor front windows do not carry out the style, and absence of corner pilasters and pediment further weaken the stylistic designation. Baber (1978 Inventory) states that 236 North Main Street is mill housing, without further elaboration, which is possible because the date of construction corresponds to the years when the textile mill was nearby to the north. The 1869 atlas gives the house the name A. Rating.
