**Address:** 43-53 North Main Street

**Contemporary Building Name:** Marlborough Country Barn

**Historic Building Name:** Cow Barn

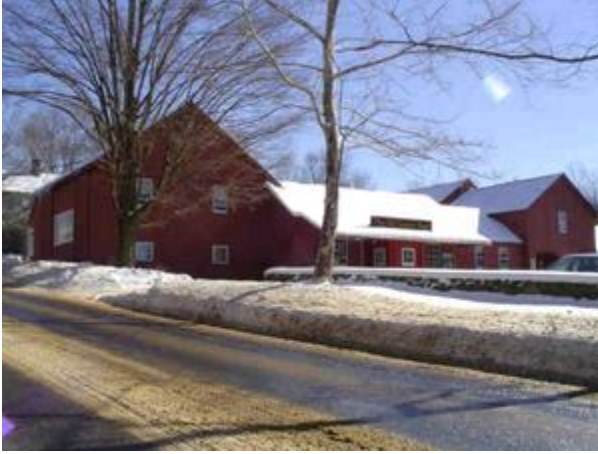
**Description:** The barn, which faces north, is a component in a grouping of connected buildings which forms one of several free-standing clusters in the retail complex. A wide shed-roofed porch runs across the front of the barn, approached by a single full-width step. The porch roof is an extension of the main roof's front slope and is supported by square posts. The central entrance is flanked by large windows of 28 small panes (7x4). On the interior, finishes are natural wood and framing is exposed. Fenestration on the rear elevation is a batten door and three six-pane windows. The components of the grouping attached to the cow barn to the west are less than 50 years old. The attached component to the east is a two-story gable-roofed historic barn with two six-pane windows at the first floor, two 6-over-6 windows at the second floor, and an attic window of four panes. The east side elevation, toward the road, has one window of 44 small panes (11x4). The next attached section of the rambling structure, to the rear (south), is less than 50 years old, but is followed by a small 12' x 22' one-story gable-roofed historic barn of vertical wood siding with an oriel of small panes in its eastern wall, under a loading door. There are two 12-over-12 windows on the south elevation.

**Significance:** The cow barn and its attached components play a roll in creating the effective overall rural and Colonial/Colonial Revival ambience of this large retail complex. While the historic buildings have been altered, especially by the introduction of Colonial Revival windows of multiple small-panes, painted white, this building complex and the site as a whole are successful in achieving an attractive setting related to historic precedent.
