Address: 9 Chapman Road

Historic Building Name: Union Mill House

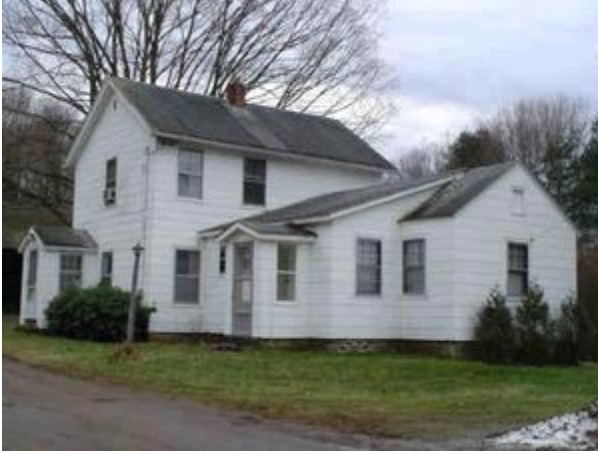
Description: The narrow front (east) elevation of 9 Chapman Road has a single central window at all three floors. Access to the house is through a small gabled entranceway to the left. A one-story shed-roofed enclosed porch with several windows runs along the entire north side elevation, facing the road. In the second floor, above, two windows are toward the front of the house. A small central corbeled brick chimney rises from the ridge.
