Address: 15 Jones Hollow Road

Historic Building Name: H.D. Barrows House, Store

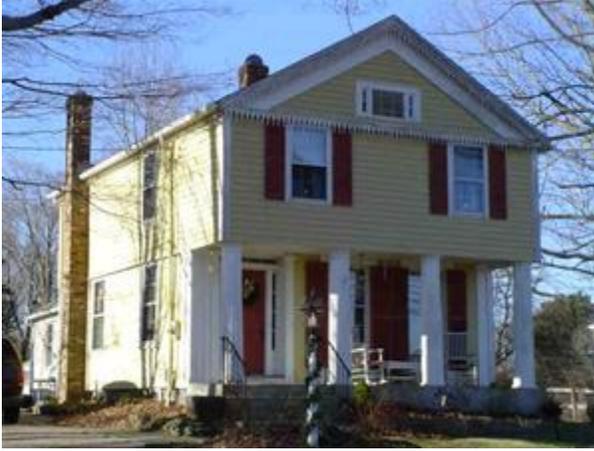
Description: 15 Jones Hollow Road is a Greek Revival house with pedimented gable end toward the street. Four fluted Doric columns are at the front of a full-width recessed concrete front porch, which is approached by four concrete risers. The columns, without entablature, support the building's second story. Behind the columnar screen, the front door with sidelights and wide flanking pilasters under a four-pane transom is to the left (south). Two floor-to-ceiling 6-over-9 windows with blinds are to the right. At the second floor the lintels of the two windows abut the cornice, without architrave or frieze. The front of the second floor, over the porch, is defined by cornerboards. The cornice is embellished with a course of small pointed drop pendants or arrows, as are the raking cornices. The raking cornices have friezes. A rectangular window is in the center of the shingled tympanum. A central brick chimney rises from the ridge while a second exterior chimney is located toward the rear on the south elevation; both are corbeled.
