Address: 3-5 East Hampton Road

Contemporary Building Name: Marlborough Tavern

Historic Building Name: Colonel Elisha Buell House

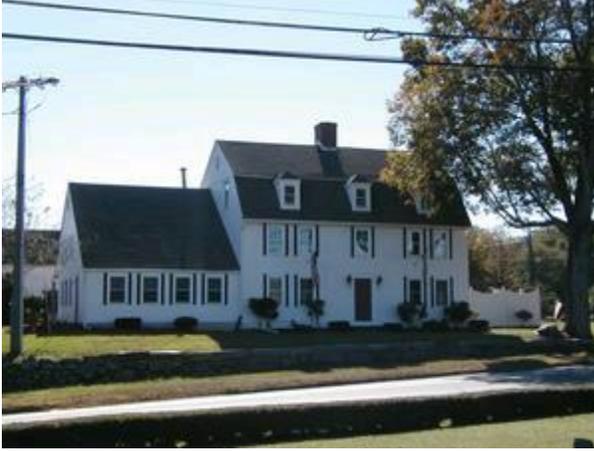
Description: The Marlborough Tavern, also known as the Colonel Elisha Buell House, is a central chimney Colonial house with a gambrel roof and three front dormers. Situated at the junction of East Hampton Road (Route 66) and South Main Street in Marlborough, the clapboarded tavern faces east and was for many years, prior to the coming of the railroad, a major stopover on the turnpike from Hartford to New London. A late 18th century ell along the north wall of the original tavern is the first of several additions which now link the old inn with its barn, which has been re-sided but retains its original interior construction. The foundations of the structure are of rough fieldstone. In the cellar, the chimney is brick. The two-story facade is heightened by the gambrel roof, the third floor lit by three dormers in the front and a fourth to the rear, in the southwest corner. The attic floor is lit by two windows, north and south; this area once served as a guardroom for prisoners on their way to Old New-gate prison and was damaged by fire in the early part of this [20th] century. The nine window clapboarded face is punctuated by a double leaved door with a simple molded architrave and a single row of five lights across the top. Paired six over six sash [windows] flank the doorway. Above, the shingled dormers (once clapboarded), six over six sashed [windows] , are topped with small hipped roofs. Narrow clapboards are framed at the corners with narrow vertical boarding. The main cornice, a plain narrow molding, comes flush with the corner boards and continues up along the pitch of the roof. To the left, along the south wall, a modern "lean-to" has been added across the first floor; it is one of several modern additions whose construction has somewhat diminished the solid lines of the original tavern. These additions are all of wood construction with clapboard sheathing and are thus at least structurally compatible with the tavern and its eighteenth century ell. A modern white picket fence surmounts the ancient fieldstone wall enclosing the yard which is planted with several old trees. The gambrel roof has recently been shingled with asphalt, but the tavern's clapboards are original. The brick chimney is centered along the ridge, with the

width facing the front of the tavern. Two courses are corbelled up to the third directly beneath the top of the chimney. The end walls of the main house both originally contained six large six over six windows and one smaller attic window; the south walls lean-to eradicates the first story windows there, while on the third floor an additional window, centered between the two original sash, has been inserted. The one-story ell dominated the north elevation of the tavern, extending to the rear of the structure for approximately 60 feet, though the oldest section built in the 18th century, occupies only a third of that length. The entrance to the ell, a door just to the rear of the tavern's northwest corner, is particularly fine, with arched panels, long strap hinges and a wrought iron latch. At the time, two chimneys divided the ell; these chimneys no longer exist though the presence of the easternmost chimney can still be noted in exposed interior beams which were cut subsequent to the ell's construction to accommodate the chimneys insertion. The joiner's framing marks can be seen on the hewn and pegged beams, illustrating the colonial craftsman's methods of construction. The shallow porch and open terrace are modern additions built after the tavern was purchased for operation as a restaurant. Still another addition, c. 1965, built out from the ell along its south wall encloses a large banquet hall. To accommodate this addition, the original stone hatchway of the tavern through which kegs were lowered into the tavern's cellar, was removed. The room is at present dominated by a massive fireplace in its northeast corner. Connected to the ell is the barn, once located closer to Route 66 but moved, c. 1950 to become part of the restaurant complex. The barn with (recently applied) vertical board sheathing and simple gable roof retains its interior framing and much of its original detail. Thus, the entire Marlborough Tavern complex consists of two main components, the old tavern, and the barn, connected by a series of ells and additions. An abundance of original detail remains within the old tavern structure. The paneled double door enters into an inner porch, situated just forward of the chimney, off of which are the two main chambers, the dining room to the right and taproom to the left, and from which the main stairway leads. It is a present unused, the main entrance to the restaurant now being through the barn. Across the rear, what were once three rooms have been opened up to form one long room the width of the tavern. The central section was once the kitchen for the tavern; the wide hearth with its crane and brick oven remains. The floors in the old tavern are ancient wide boards. In the taproom, the present flooring comes from what was once the guardroom in the attic. Likewise, the bar and its grill, a screen with slats which hinged to the ceiling and could be lowered in the event of a rowdy crowd, is a careful reproduction (using old wood) of the bar which stood in the southwest corner of the taproom. In both of the two main chambers, the taproom and the dining room, the chimney wall is covered with paneling; wall cupboards exist in both panels. Flared posts are visible in the old house although the summer beam is obscured by plastering on the second floor, the tavern's ball-room has a swinging partition which could be used to divide it into smaller rooms. Despite additions, which confuse but do not obscure its integrity, the Marlborough Tavern, a late colonial country inn, survives today and continues to serve, as it has for many years, the hungry traveler.
