**Address:** 34 North Main Street

**Historic Building Name:** Congregational Church Parsonage

**Architectural style:** Greek Revival / Vernacular

**Date constructed:** c. 1850 (Baber), 1750 (Assessor)

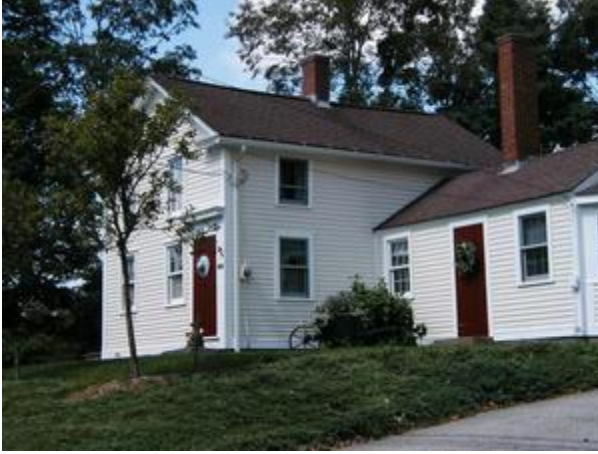
**Description:** The gable-end front elevation of the Parsonage has two 6-over-6 windows and a door at the first floor. The door is fitted into the small space between the south window and the nearby cornerboard. Basically, the Parsonage is a two-bay house. The front doorway, otherwise plain, is embellished with a frieze and heavy bold cornice. The second floor has two windows. The eaves return slightly below the level of the second-floor caps. There is no window in the gable end above. The raking eaves have no fascias. A small brick chimney rises from the center of the roof ridge. On the south side elevation windows at the second floor are 6-over-3, in conformity with the fact the house is less than a full two stories high. A fascia runs under the eaves on the side elevations. A long narrow wing/ell is set back on the south side elevation. Its central front door is flanked by single windows. On the north side elevation of the main block there are two windows at both first and second floors.
