Address: 43-53 North Main Street

Contemporary Building Name: Marlborough Country Barn

Historic Building Name: Cow Barn

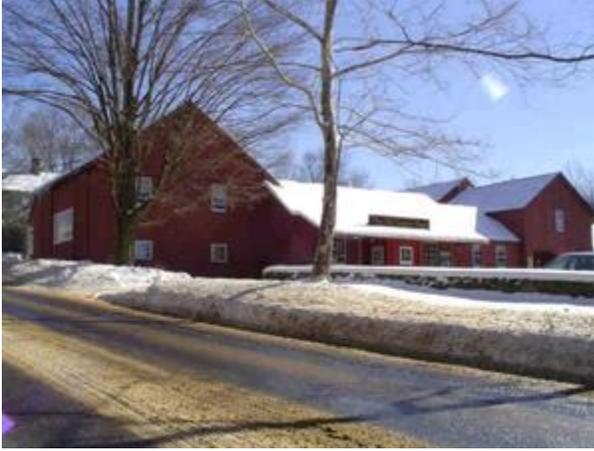
Description: The barn, which faces north, is a component in a grouping of connected buildings which forms one of several free-standing clusters in the retail complex. A wide shed-roofed porch runs across the front of the barn, approached by a single full-width step. The porch roof is an extension of the main roof's front slope and is supported by square posts. The central entrance is flanked by large windows of 28 small panes (7x4). On the interior, finishes are natural wood and framing is exposed. Fenestration on the rear elevation is a batten door and three six-pane windows. The components of the grouping attached to the cow barn to the west are less than 50 years old. The attached component to the east is a two-story gable-roofed historic barn with two six-pane windows at the first floor, two 6-over-6 windows at the second floor, and an attic window of four panes. The east side elevation, toward the road, has one window of 44 small panes (11x4). The next attached section of the rambling structure, to the rear (south), is less than 50 years old, but is followed by a small 12' x 22' one-story gable-roofed historic barn of vertical wood siding with an oriel of small panes in its eastern wall, under a loading door. There are two 12-over-12 windows on the south elevation.
