Address: 73 Hebron Road

Contemporary Building Name: 73 Hebron Road

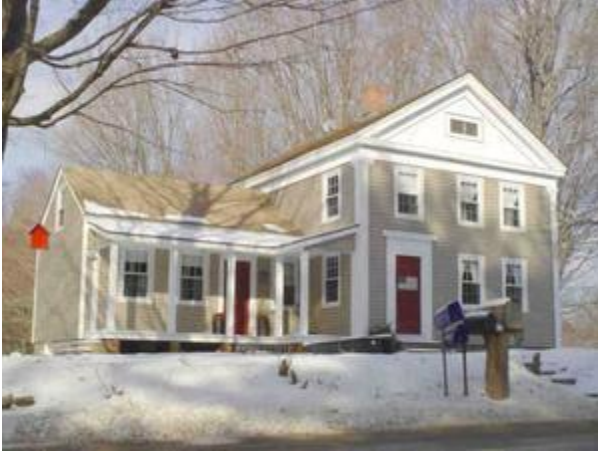
Description: In the three-bay front elevation, the doorway is in the west bay. It is flanked by pilasters which support an entablature. Windows are 6-over-6. Corner pilasters run up to a frieze which surrounds the house. The gable end is treated as a pediment, covered with flush boarding and with a central horizontal rectangular window. The raking cornices of the pediment have parallel friezes. The one-story wing to the west is set behind a shed-roofed front porch which has slender square posts joined to the eaves with sawn brackets. Steps of large stone blocks rise from the highway to the porch entry, indicating that the porch and wing are old, probably dating from the 19th century.

Significance: The house at 73 Hebron Road is significant because it is a good example of the Greek Revival style, exhibiting the basic temple-form gable-end shape and the simple, strong proportions associated with the style. In addition, many individual features are characteristic of the Greek Revival style, including doorway and corner pilasters, 6-over-6 windows, and tympanum with friezes, flush boarding, and rectangular window. The apparent age of the wing supports the overall integrity of the resource.
